Nambucca Heads to Urunga

Low Noise Diamond Grinding
Pavement Noise Monitoring

Roads and Maritime Services | July 2019

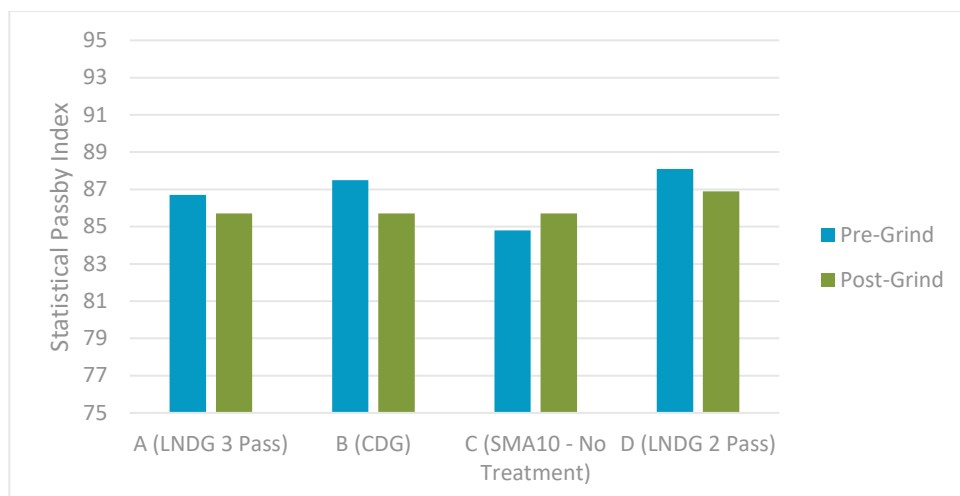
Figure 4 Summary of Statistical Passby Index at All Locations

The Statistical Passby Index at each location pre and post grinding is also shown in **Figure 4**, and the Vehicle Sound Level data is shown in **Figure 5** to **Figure 8** for each of the four test locations.

The SPB measurements shown in **Table 6** and **Figure 4** indicate the post-grinding SPBI at Location D (LNDG 2 Pass) is around 1 dB higher than the other three sites, which is primarily due to the higher Class 2a and Class 2b levels. Post-grind Class 1 levels at Location D (LNDG 2 Pass) are similar or better than the other three sites.

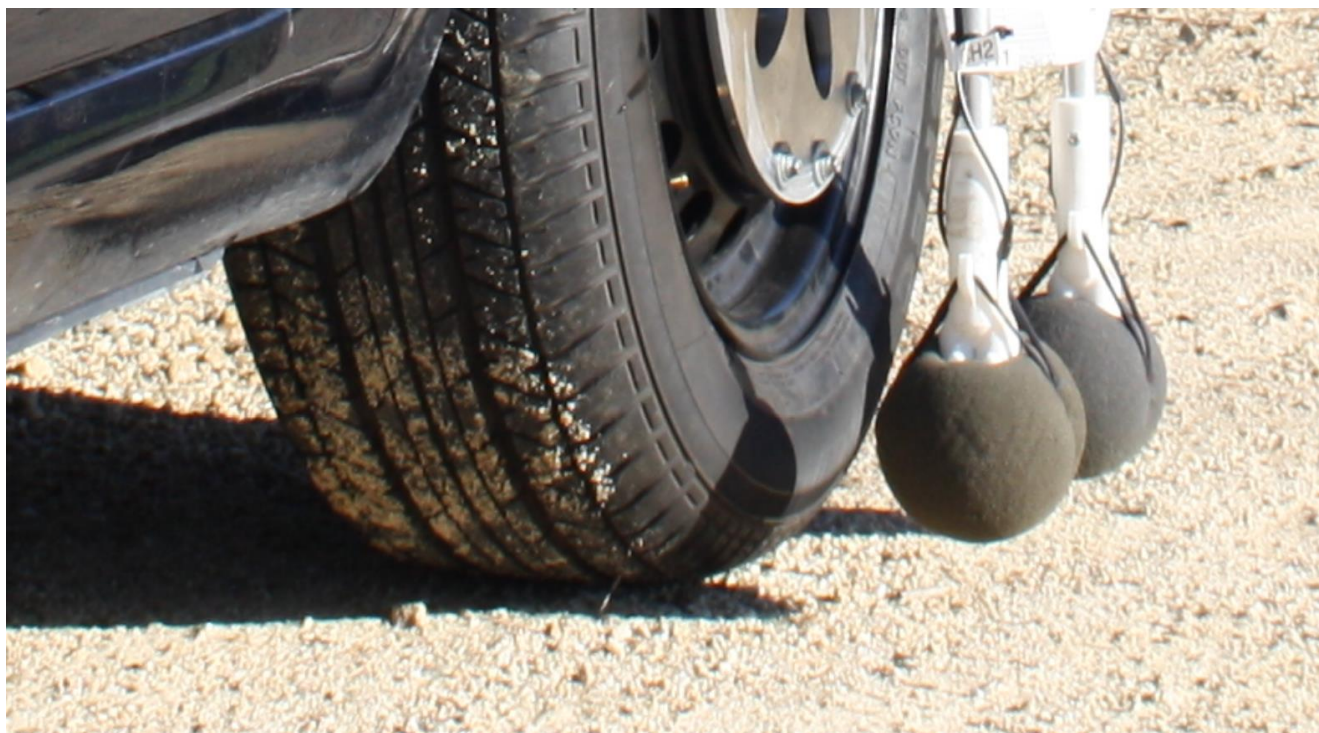
Figure C10 Yokohama ASPEC A300 Tyre Tread

Item	Details
Vehicle	Toyota Corolla Ascent Hatch (2009)
Tyre	Yokohama ASPEC A300 ¹
Parameters measured	<ul style="list-style-type: none">- Raw sound pressure was recorded at a sampling frequency of 48 kHz and a bit depth of 16 on four channels simultaneously using two pairs of phase-matched microphones.- Speed and geo-position were continuously recorded using a GPS.- Temperature of both the tyres and road surface was measured before and after each run using an infrared thermometer.
Measurements made	<ul style="list-style-type: none">- All data was recorded for various loops of the motorway which covered all the testing locations in both the northbound and southbound directions. Segments of the pressure traces were then extracted for analysis where the geo-position of the vehicle was in close proximity to each SPB measurement location.
Vehicle speed	The nominal speed of the vehicle was 110 km/h, which was the posted speed limit. Vehicle speed was continuously recorded using a GPS connected to a laptop. A heads-up display was provided to the driver to ensure the speed was correct and consistent.

Note 1: A photo of the tread pattern is provided in **Appendix C**.
