Port Macquarie southern breakwall upgrade

Review of Environmental Factors

Transport for NSW | June 2022

Prepared by Blue Sky Planning and Environment on behalf of Transport for NSW

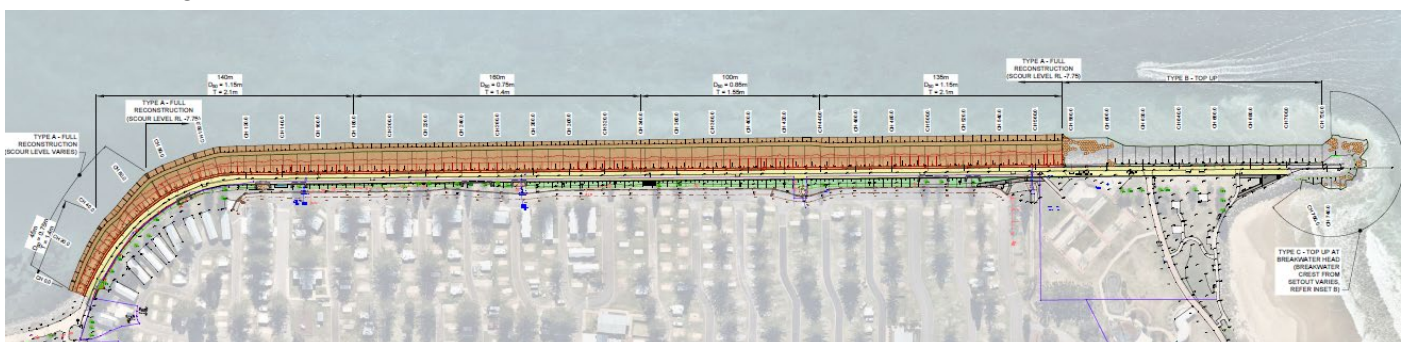
Figure 1: Proposed Footprint (Source: Royal Haskoning DHV)

The total length of the breakwall to be upgraded is about 700 metres in length. The proposal footprint is depicted in Figure 1 below.

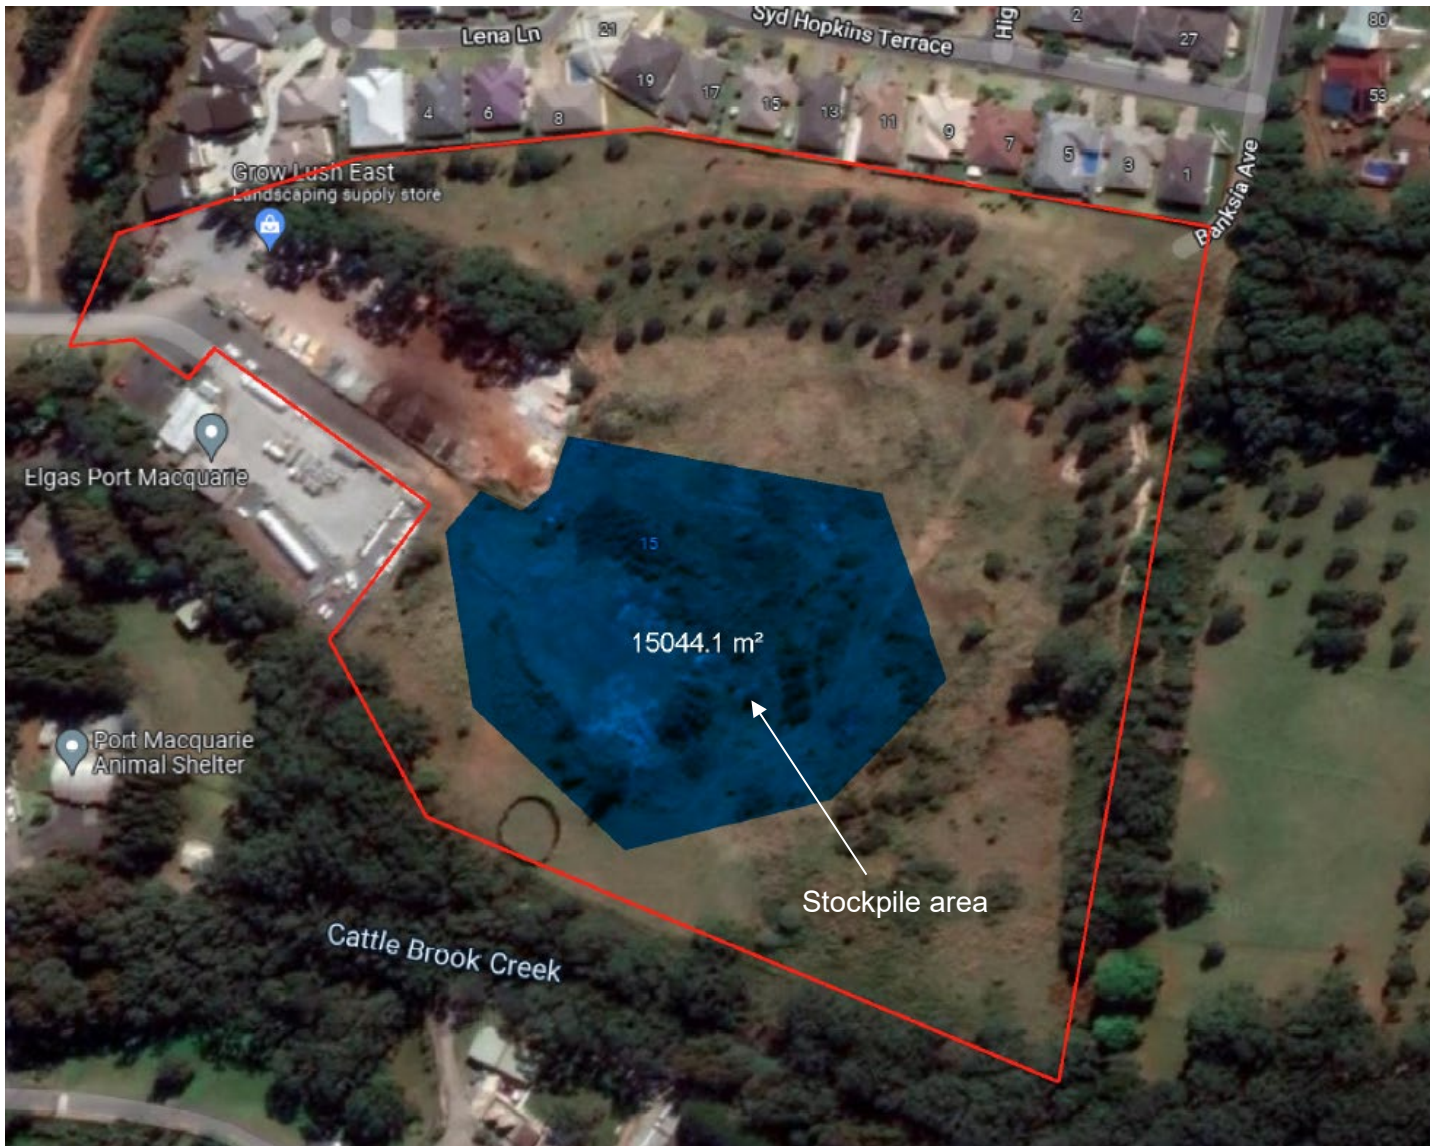
Figure 7: Proposed off-site stockpile site and nominated stockpile area at John Fraser Place (Source: Google Maps)

Figure 7 below depicts the off-site stockpile site and nominated stockpile area within that site.

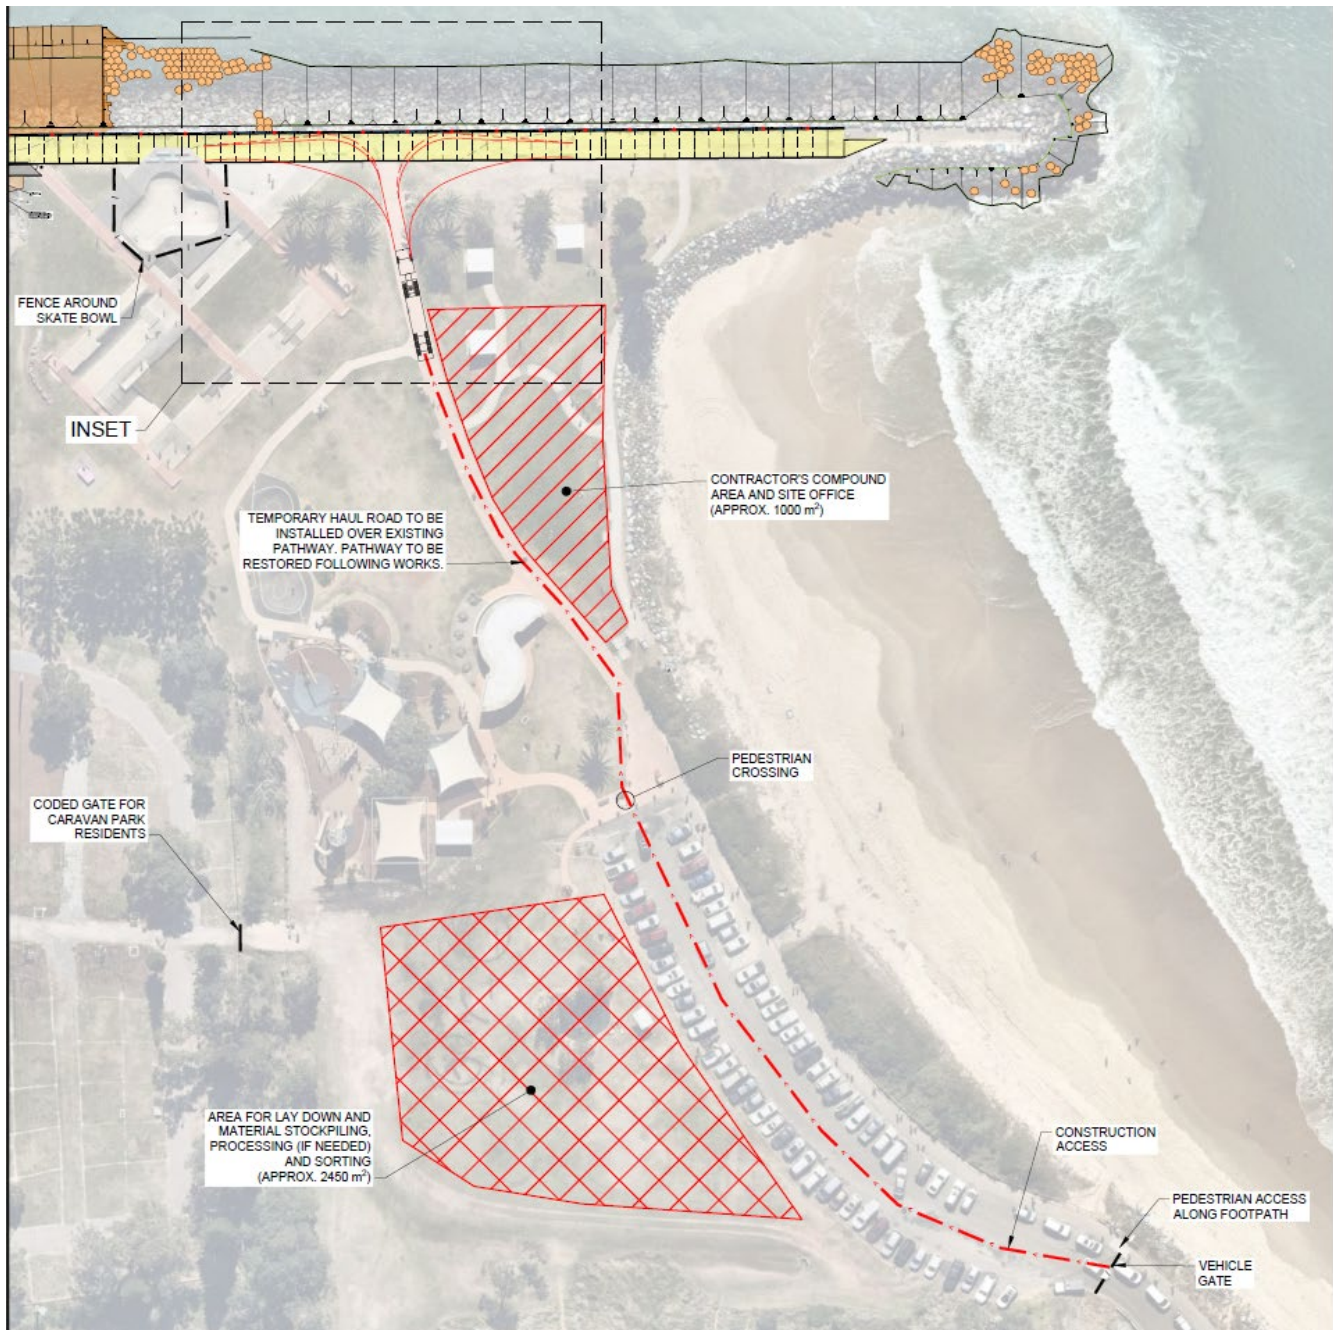
Figure 8: Proposed on-site stockpile site and temporary construction compound located near proposed project footprint (Source: Royal Haskoning DHV, March 2022)

Figure 8 below depicts the stockpile site located near the proposed project footprint.

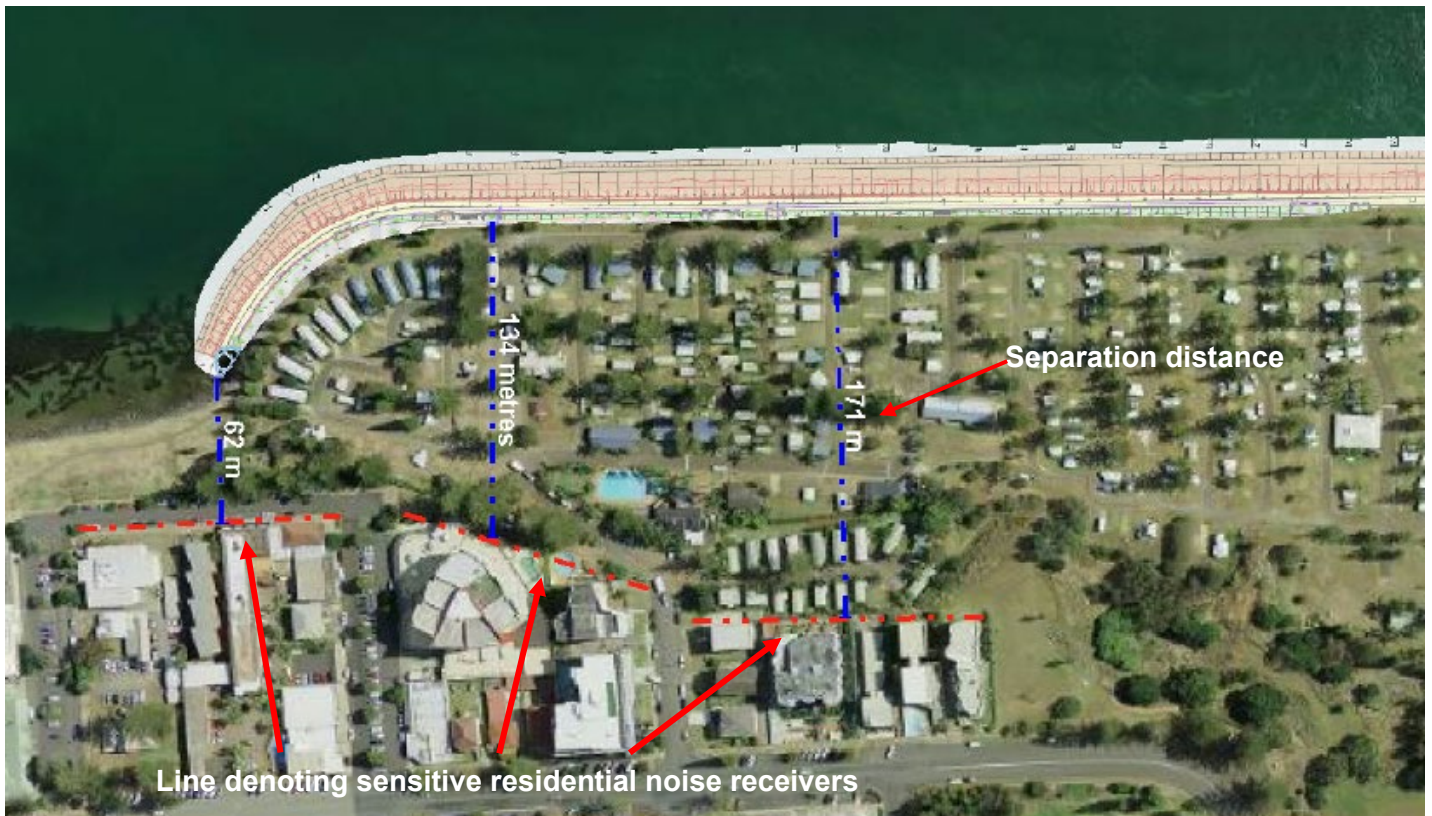
Figure 10: Proximity to sensitive noise receivers at the breakwall

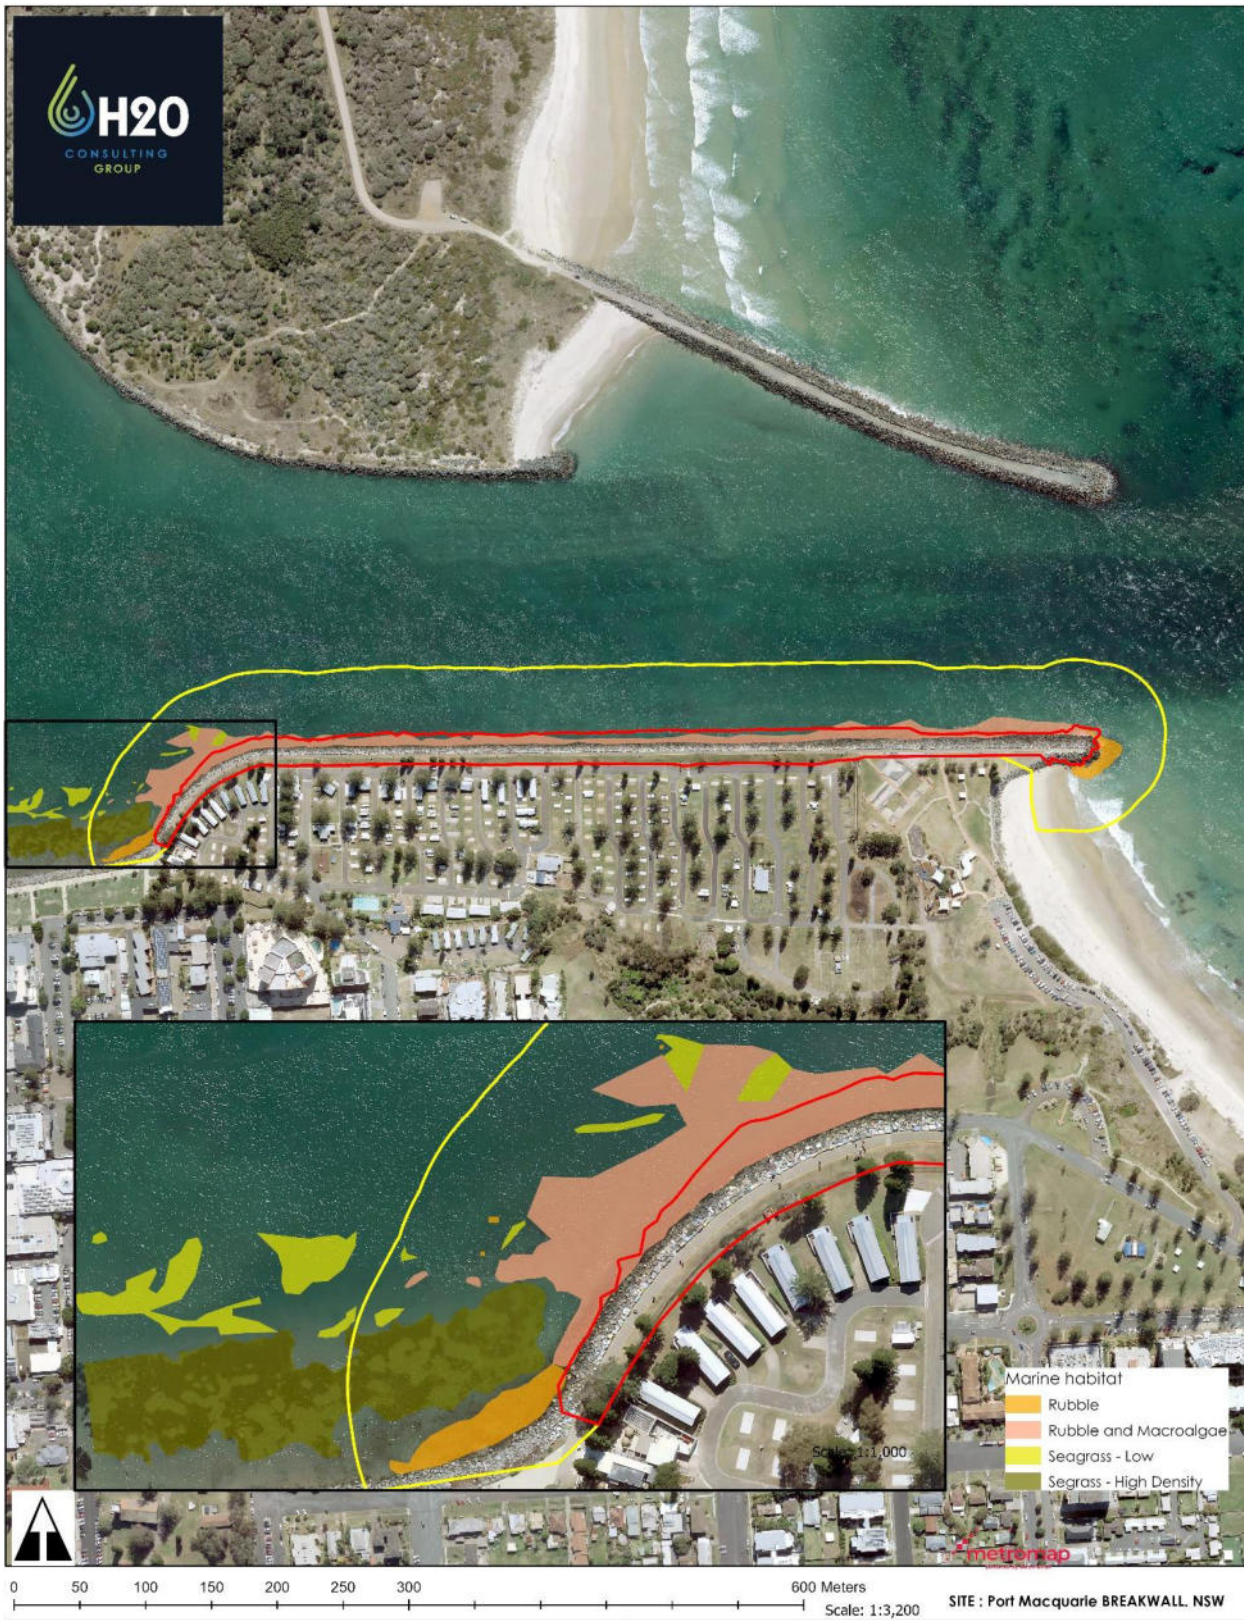
Figure 3: Habitat Map.

Figure 3 : Habitat Map		Projected Coordinate System		GDA 2020 Zone 56	
<div><div></div> - Project Area</div> <div><div></div> - Study Area</div>		DATE : 17/02/2022		Map Version : 1.0	
		<div>MetroMap Aerial : Captured 20/09/2021</div> <div>Although all care has been taken - WiZarDtech accepts no responsibility from the use or inaccuracies of this map and spatial data.</div> <div>Copyright © WiZarDtech Spatial Services 2021.</div>

Patchy *Zostera capricorni* seagrass beds were found in shallow areas (typically < 4 m) in the western part of the Study Area. These included high-density beds of *Z. capricorni* (Plate 4) that commence at the toe of the western section of the breakwater, as well as some smaller, low-density patches in deeper areas to the northwest of the breakwater (Figure 3).

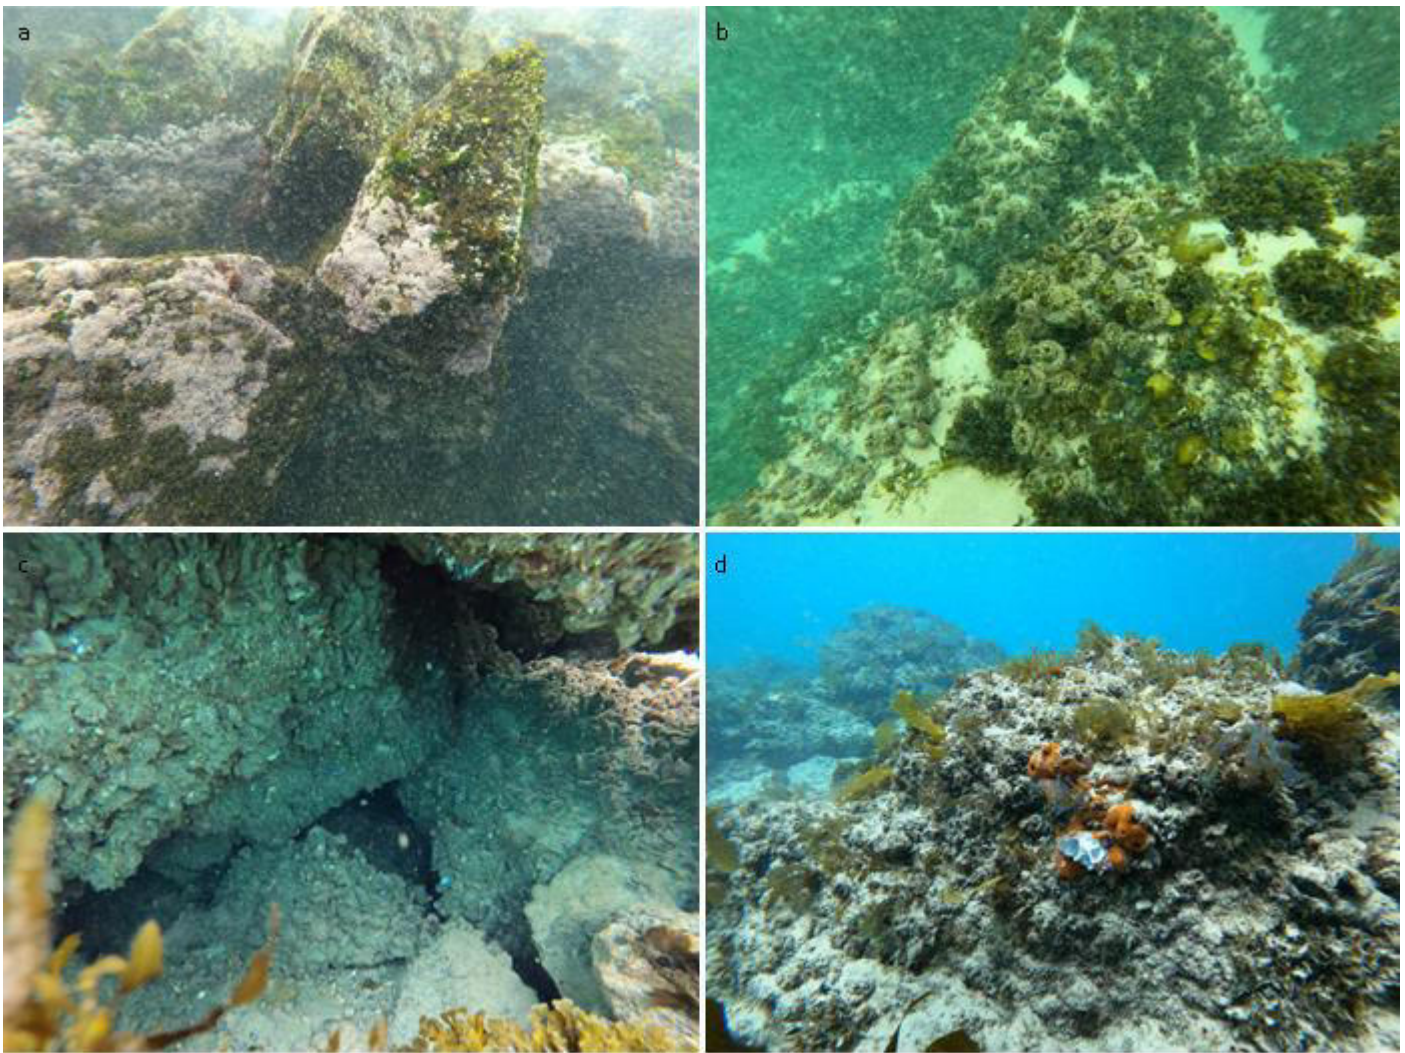
Plate 3: Subtidal habitat on the breakwater.

A: Dense algal mat dominated by Coralline and brown macroalgae in shallow areas, B: Ascidian beds dominating lower rocks, C crevices and overhangs amongst the rocks, and D: loose rocks with macroalgae at the breakwater toe.

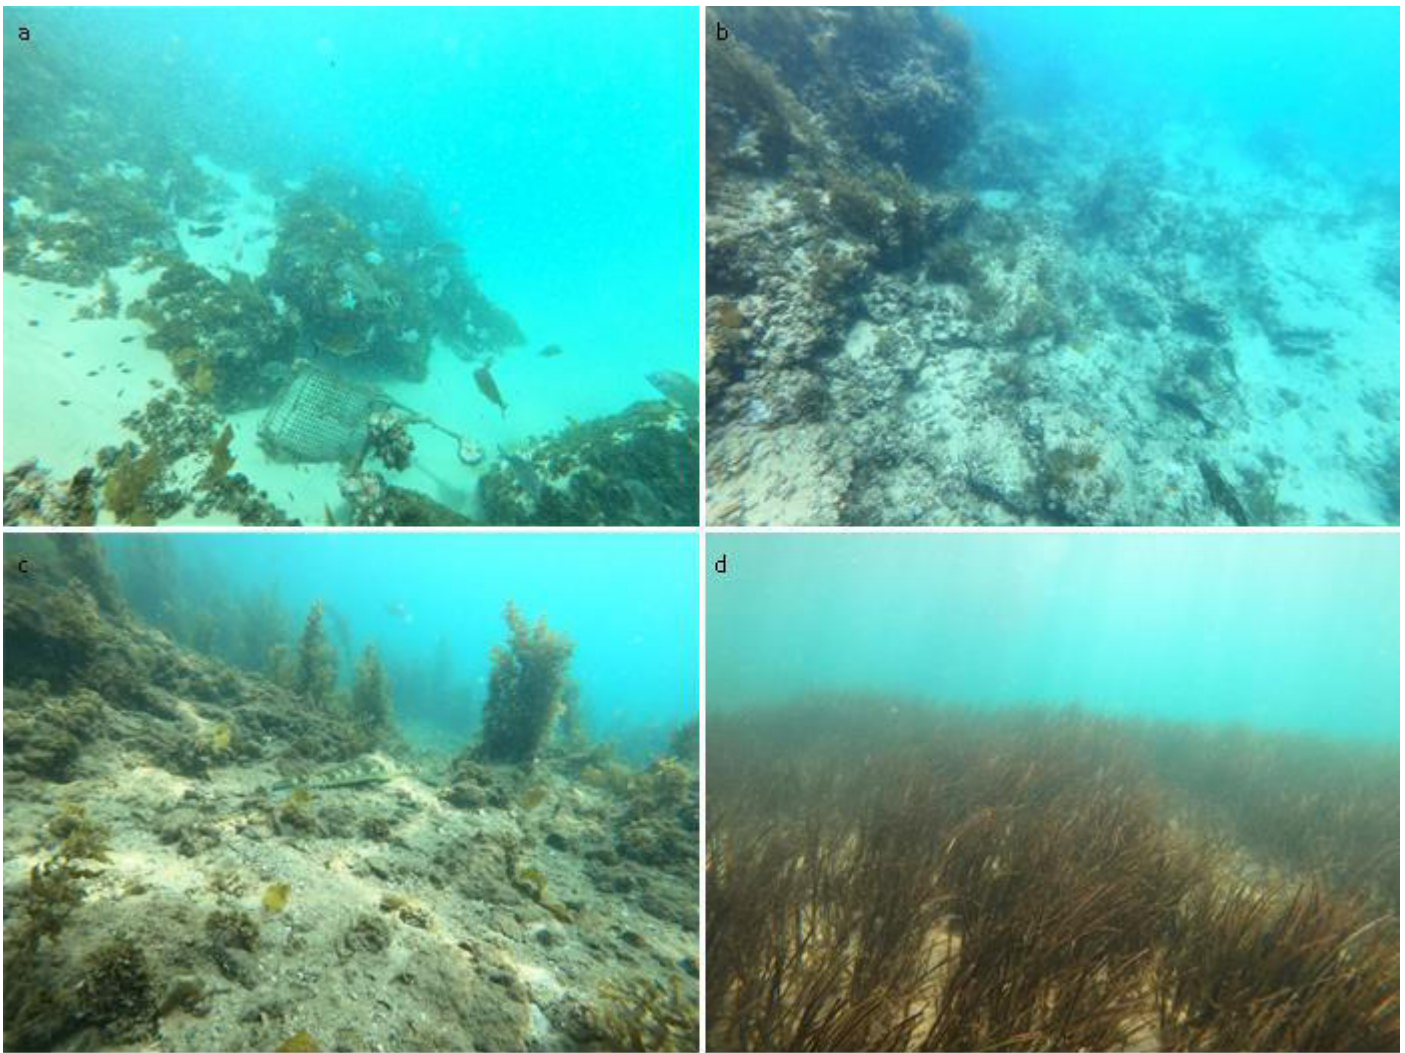
Plate 4: Sub-tidal habitat in the Study Area.

A: Sand and rock interface at the breakwater toe with clean marine sands and rocks, B: Sand and rock interface at the breakwater toe with rubble and algae, C: Rubble and sargassum beds on the north western side of the breakwater , and D:Dense *Zostera* seagrass beds to the west of the breakwater.

The subtidal habitat within the Project Area included the toe of the breakwater, which extends 5–10 m out into the water from the breakwater at a 45–60-degree gradient. Lower (subtidal) sections of the breakwater were constructed of similar-sized large and haphazardly placed armour rock to that present in the intertidal area. Beyond the end of the toe of the breakwater the subtidal habitat consisted of a moderately sloping (15–30 degrees) soft sediment bottom. These sediments typically consisted of clean marine sands, although became siltier towards the western extent of the breakwater and to the west of the breakwater, where some seagrasses were found to occur. Some large rocks and patches of rubble occasionally occurred in those areas of soft sediment within 10 m of the breakwater toe. These rocks and rubble appear to have originated on the breakwater above, having been dislodged over time (Plates 3 and 4).

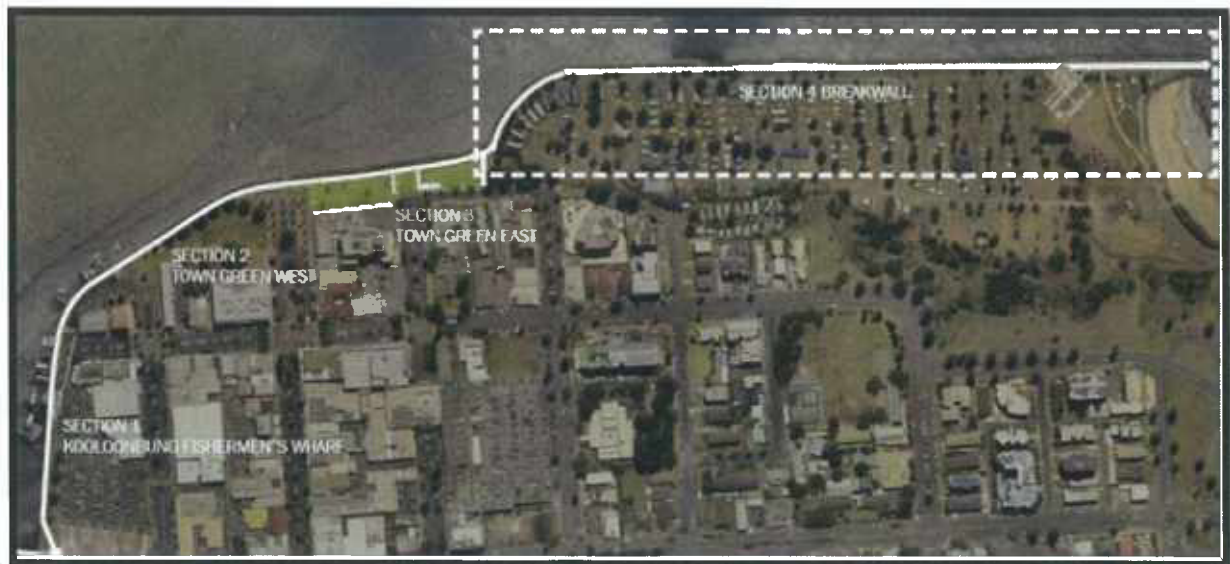
Figure 4: Section 4.

The proposed works include the breakwater head and the inner river revetment and crest path with a distance of approximately 700 metres in length as shown in Section 4 in **Figure 4** below.

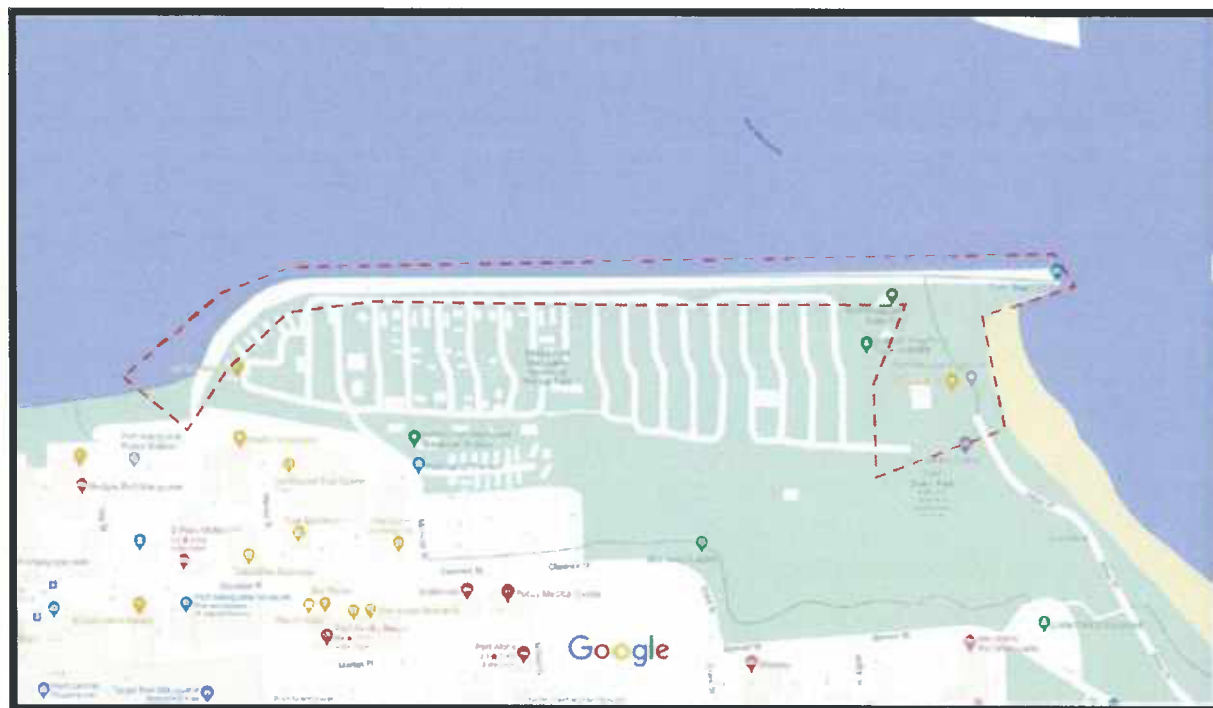
Figure 5: Extent of works (red dotted outline)

Royal Haskoning Australia (RHA) has been engaged by MIDO to undertake detailed assessment and to develop a detailed design for the proposed upgrade works. Information prepared by (RHA) should be used to inform the Review of Environmental Factors (REF).

The search indicates that there is an Aboriginal place or item, however it is situated approximately 250 metres from the western extent of the proposed works (See **Figures 5 & 6**) therefore, it is considered the project will not have any impact on the identified cultural item or site.

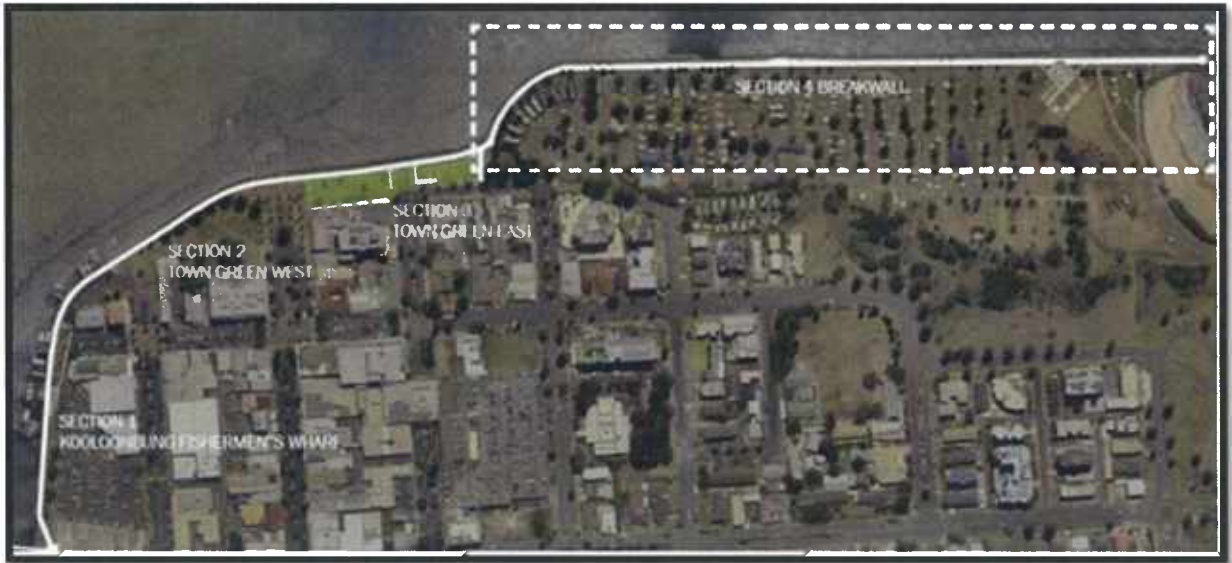
Figure 4: Section 4.

The proposed works include the breakwater head and the inner river revetment and crest path with approximately 700 metres in length as shown in Section 4 in **Figure 4** below.

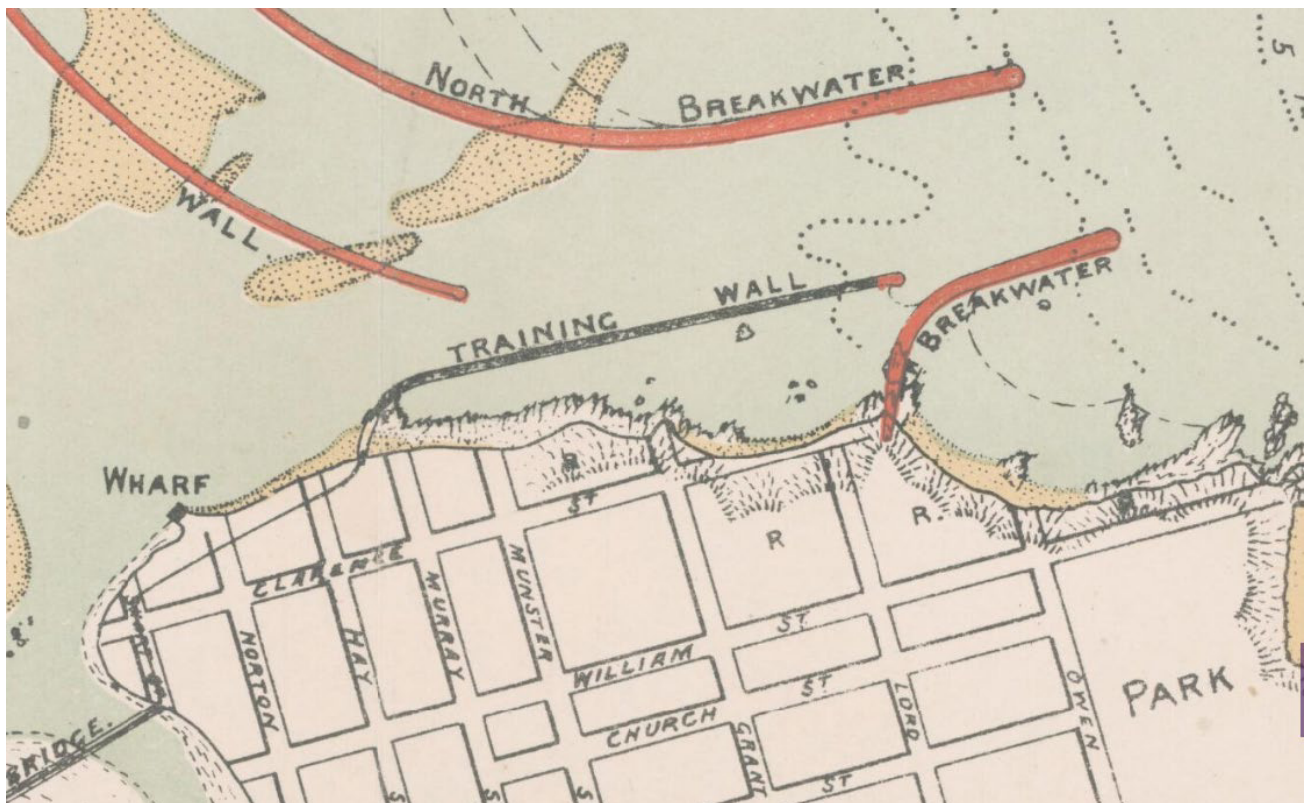
Plate 4.4 1901, New South Wales harbours: Hastings River entrance. Source: NLA MAP RM 5096.

Plate 4.4 shows the extent of the completed southern breakwall training wall in black. The red structures were proposed breakwalls that were not built. The tramline can be seen as a single line leading from the training wall over Kooloonbung Creek to the west.

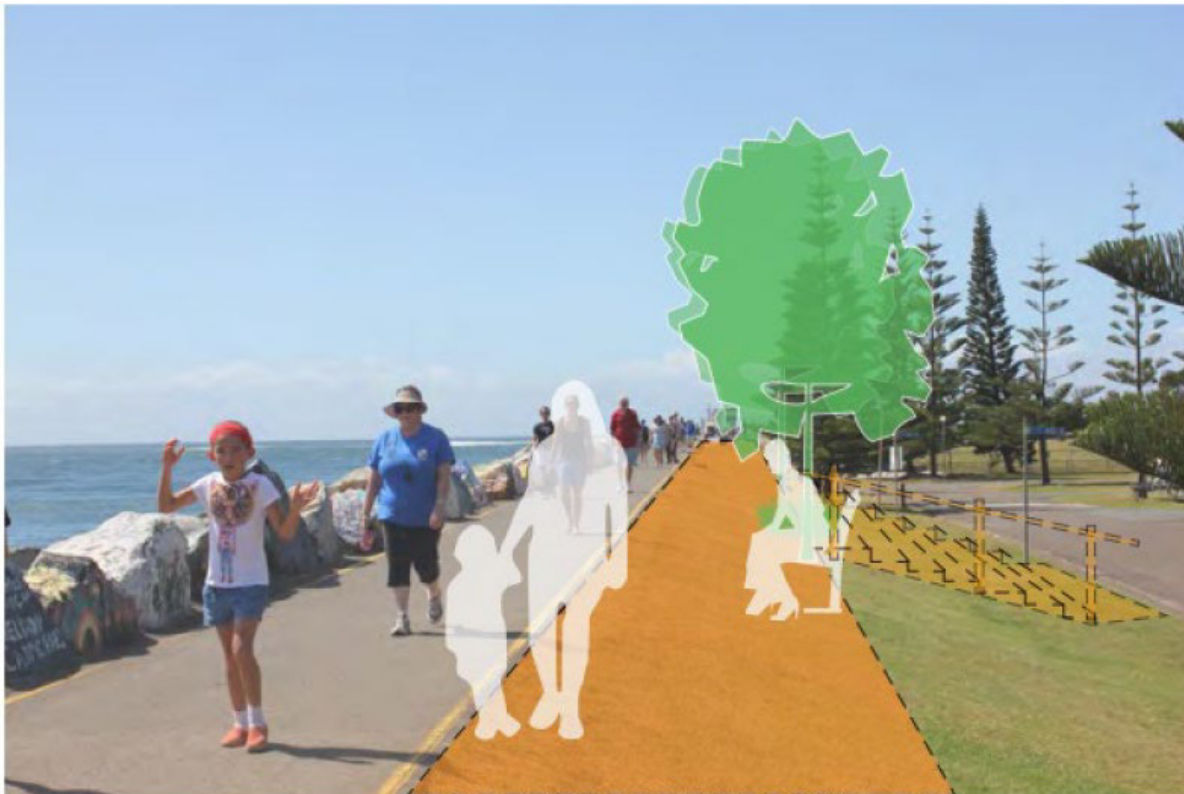
Plate 7.7 Mock-up plan of proposed crest path upgrade works within the current landscape. From Breakwall Master Plan extract in proposal (Haskoning Australia Pty Ltd, 2021, p.7)

Crest Path: The existing breakwall pedestrian path will be extended south into the current embankment area (Plate 7.5, Plate 7.6, Plate 7.7). The width of the public path will increase in width from 2.5 m to 5 m. As a result, the current inner embankment will decrease in width from 7.5 m to 3.5 m. The original path will be removed along the “full reconstruction” area and formed concrete retaining walls will be installed abutting the outer revetment armour and along the inner crest. Compacted sterile fill will be added to level the path area between the retaining walls which will be topped with the poured concrete walkway reinforced with steel mesh.
